Manhole Inspection Summary

Manhole # S37MM_148MH

Insp Date: **6/30/08 10:05 AM**

Location Address: **1914 OAKHILL AVE**

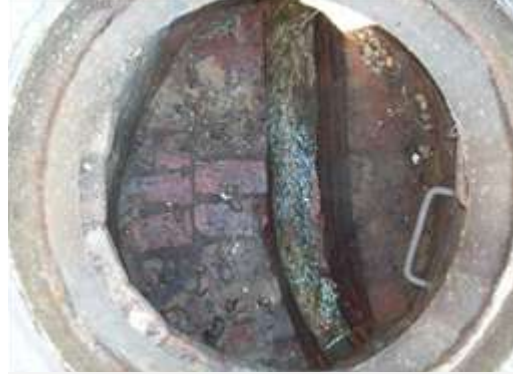
Top View

☐ Parged ☒ **Debris** (not Condition related)

Steps Count: **2** Missing: **0** ☒ **Corroded**

Surcharge ☒ **Evidence Of Surcharge** Depth: **1** (ft.) ☐ Active Surcharge Present

Corroded steps. Evidence of surcharge - Bench debris.

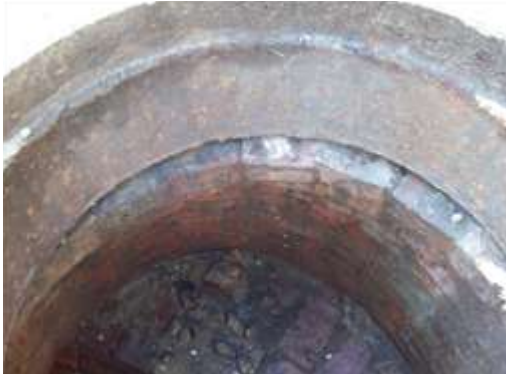
Defect

Frame Offset: **1** (in.)

☒ **Leaks**

Condition: ☐ Sound ☐ Cracked ☐ Root Intrusion ☐ Loose Brick ☒ **Deteriorated**

Infiltration: ☐ None ☒ **Joint** ☐ Cracks ☐ Mortar ☐ Roots ☒ **Wall**

Infiltration: ☐ None ☐ Joint ☐ Cracks ☒ **Mortar** ☐ Roots ☒ **Wall**

Frame leak. Frame offset. Adjustment deterioration and infiltration. Corbel and Barrel infiltration.

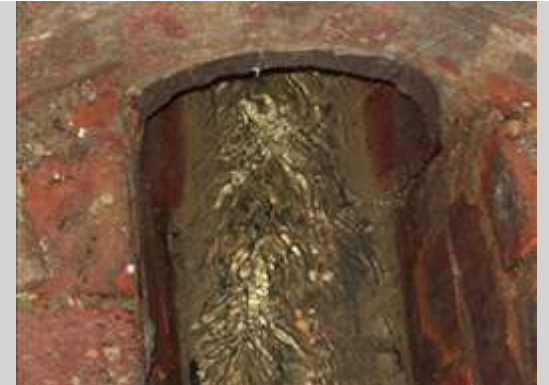
8 in. Circular Gravity Sewer Pipe Out @ 12 O'Clock

Infiltration: **Evidence** Pipe Seal Cond: **Unknown**
